Montgomery County Fire and Rescue Service

POST INCIDENT ANALYSIS

**Inhalation Emergency
14200 Wolf Creek Place
Silver Spring, MD**

Incident Date: November 18, 2011

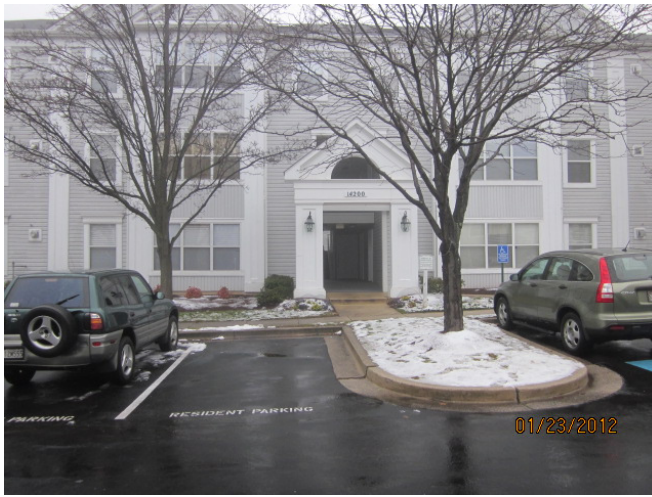
Side Alpha of #14200 – center stairwell.

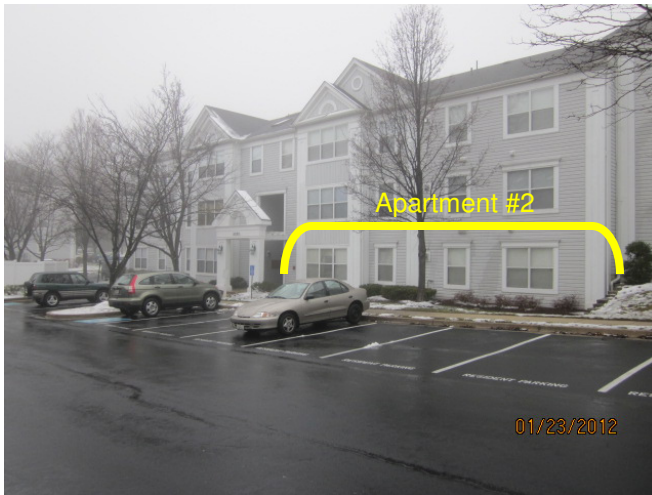
Side Alpha – showing the large size of the apartments.

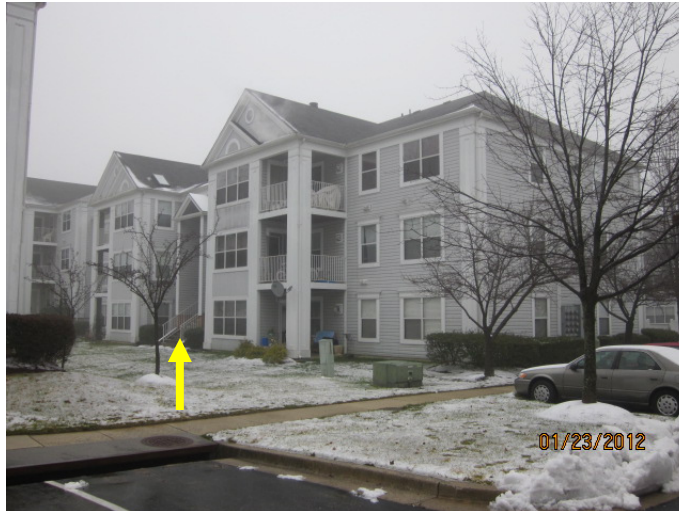
Side Charlie – same open stairwell.
